## ACE Project Report for Landward Foundation

**Title of Project:** Little Colorado River Valley Conservation Area Riparian Restoration

**Location:** Babbitt Ranches, Little Colorado River Valley Conservation Area

**Dates:** 1/22/2020 - 3/25/2020

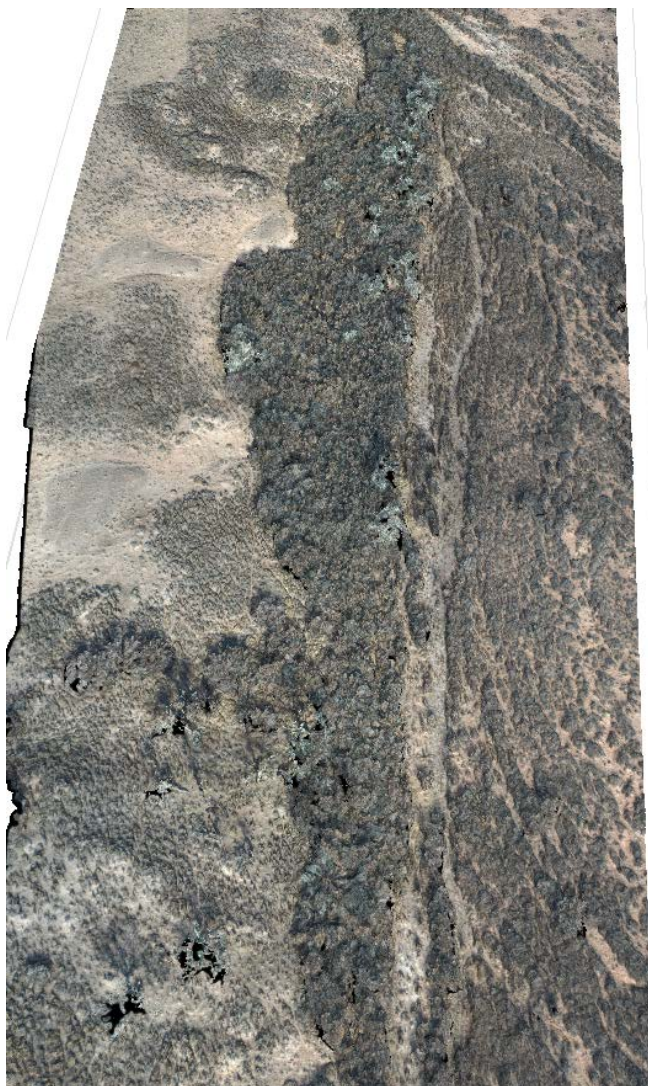
(Left) Ariel image of the 6-acre Landsward restoration site, before project work began. Individual cottonwood trees stand out as bright green versus the dark green tamarisk. North is at the top of the photo.

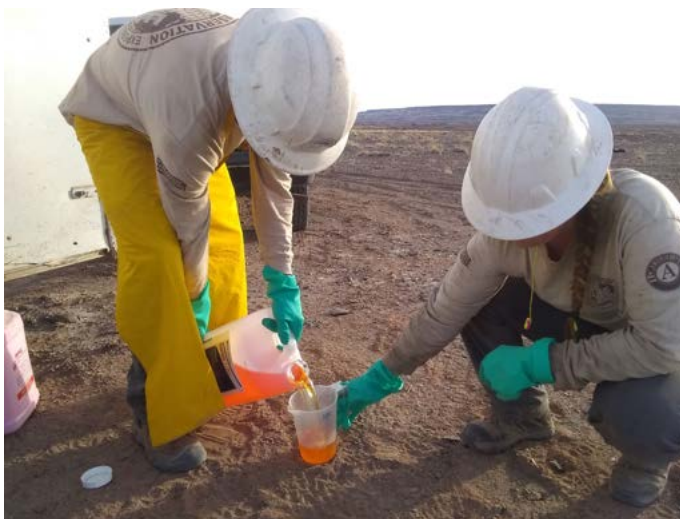
Left: Two corps members work together after being taught how to properly mix herbicide to prepare our chemical for modified cut-stump treatment. By mixing the herbicide with basal oil they create a solution that will be easily absorbed by tamarisk.

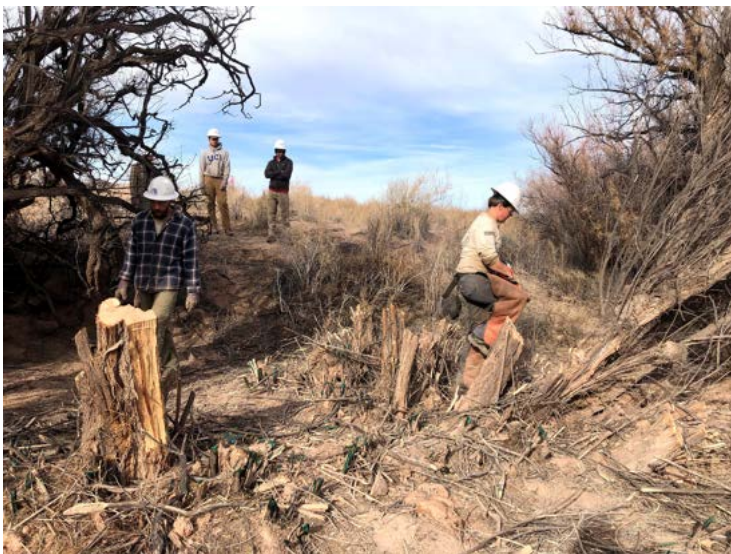
Left: One of our sawyers clearing our a corridor for the proposed fence line. Our sawyers high stump first before low stumping for the herbicide treatment. The herbicide must be applied shortly after the cut is made or the chemical won't be absorbed.

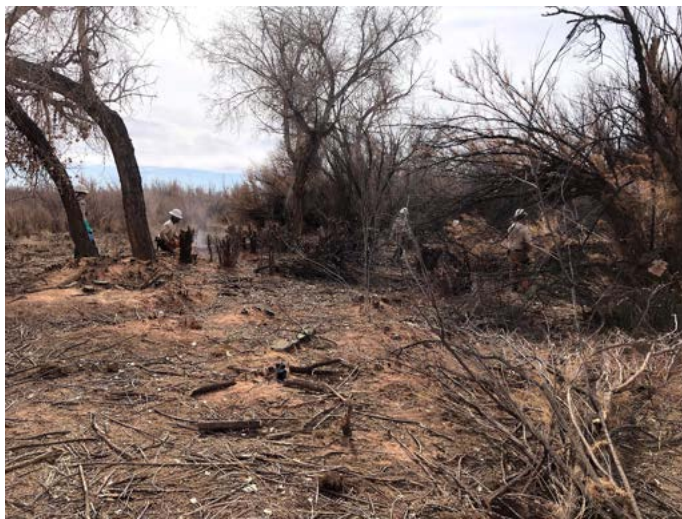
Tamarisk forces native plant species to compete for resources such as water, sunlight, and soil nutrients. By removing the tamarisk from around native cottonwoods (Left) and desert olive our hope is to lessen their need to compete for vital resources while creating a defensible area against fire threats.

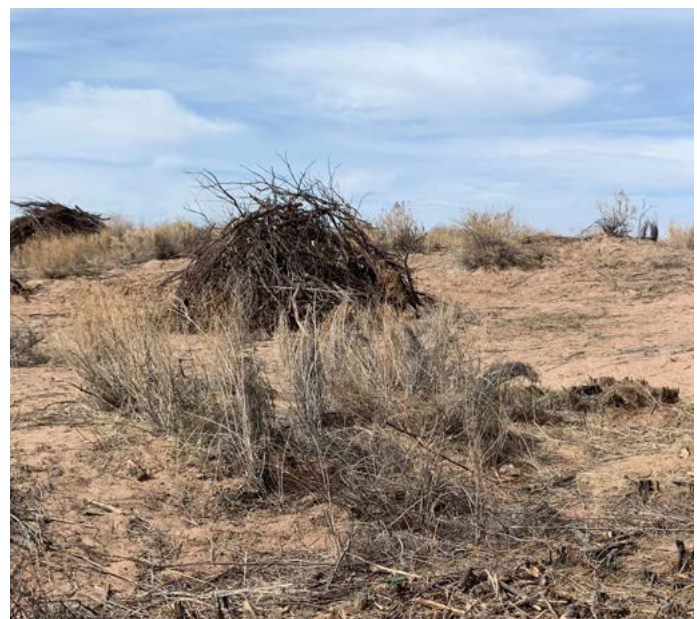
Swampers hauled away the debris and constructed burns piles (Right). These piles had to be constructed two chains (132 ft) away from any standing tamarisk and cottonwoods.

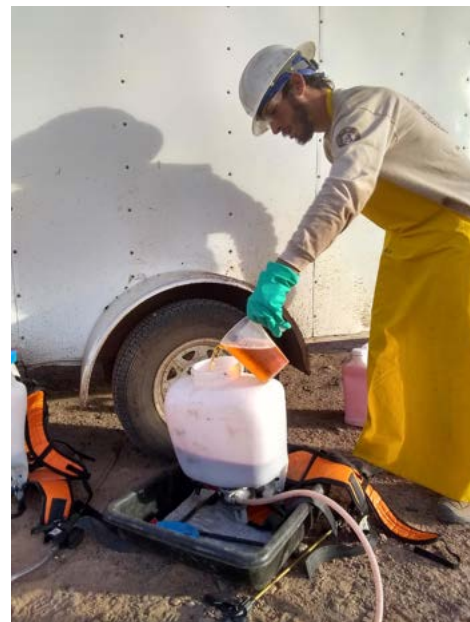
Herbicide also included a red or blue dye that helps identify which stumps have been treated. For cut-stump treatment (Left) only the cambian layer of the tree needs to be sprayed. This is the same for modified cut-stump, but in addition to the cambian layer we would also treat the outer bark of the stump.

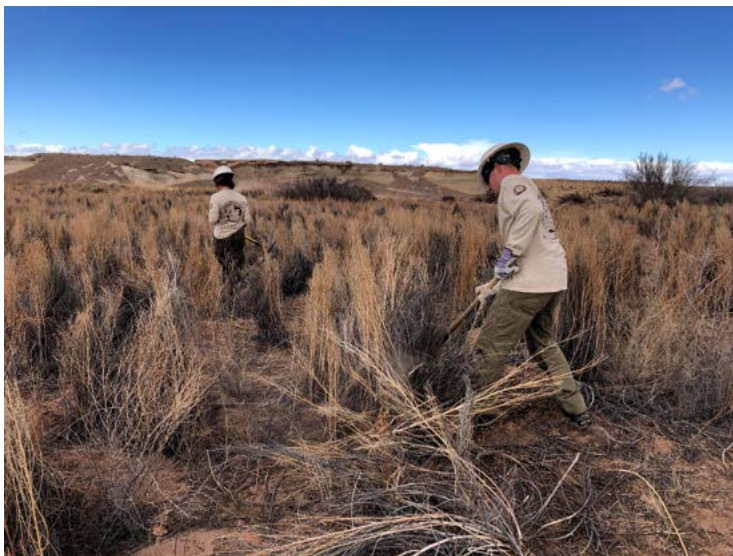
(Left) Prior to constructing the fence line corps members had to remove invasive camelthorn and grasses so that wire could be run without obstruction.

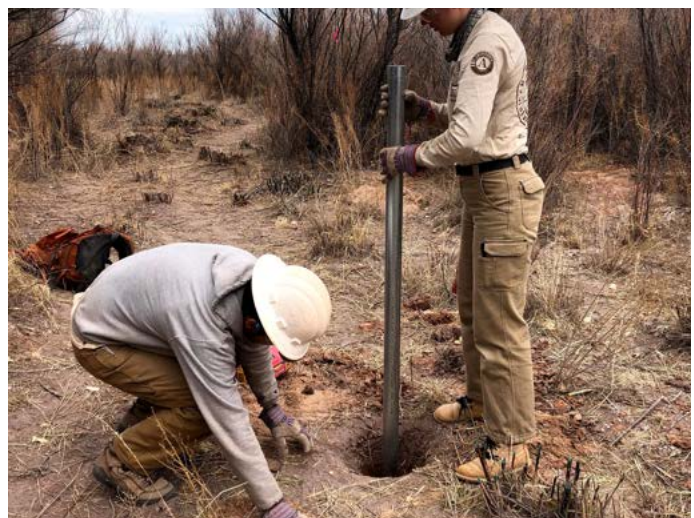
Before T-posts could be set and wire run, the corner braces had to be installed. These braces (Right) were set into concrete to increase their strength and durability. These vertical posts were paired with two additional angle bracers.

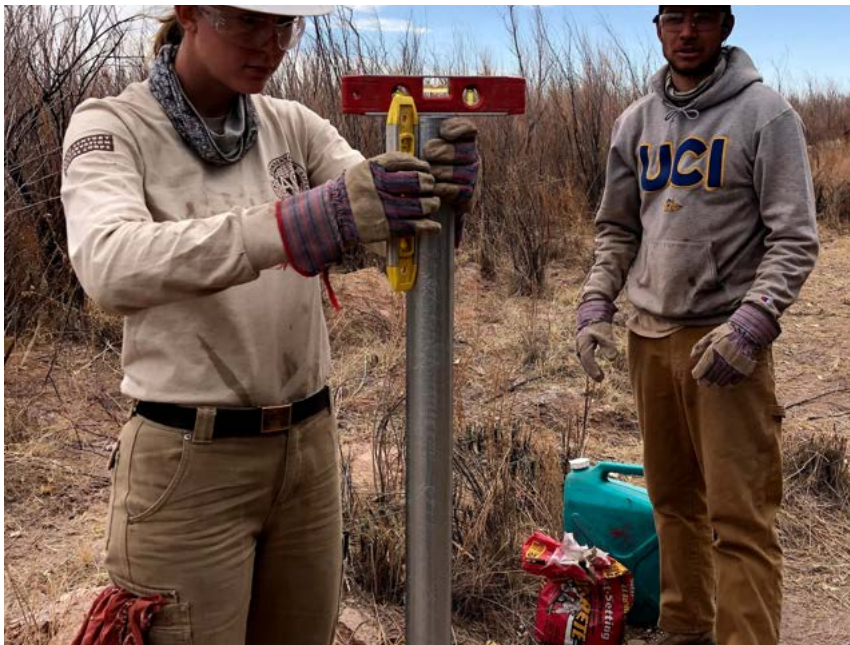
(Left) Prior to setting the brace with concrete corps members checked to ensure that the brace was standing straight.

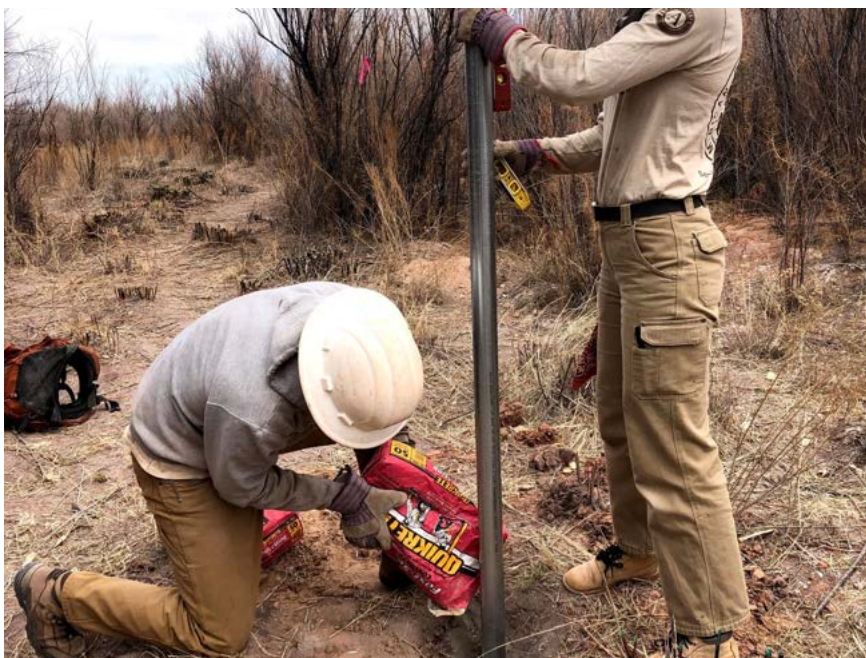
(Left) Concrete being poured into the post hole prior to adding water to set the post.

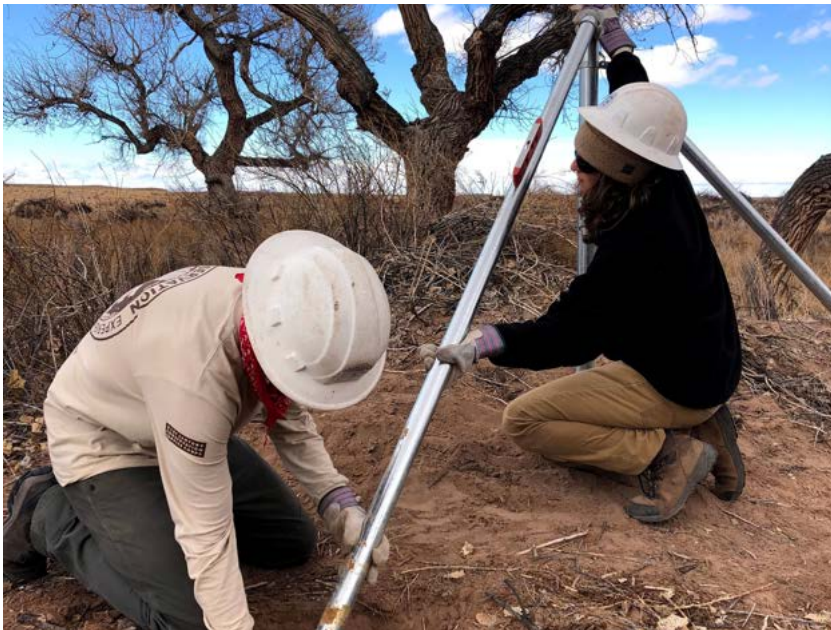
(Left) Setting the supporting angle posts for corner braces.

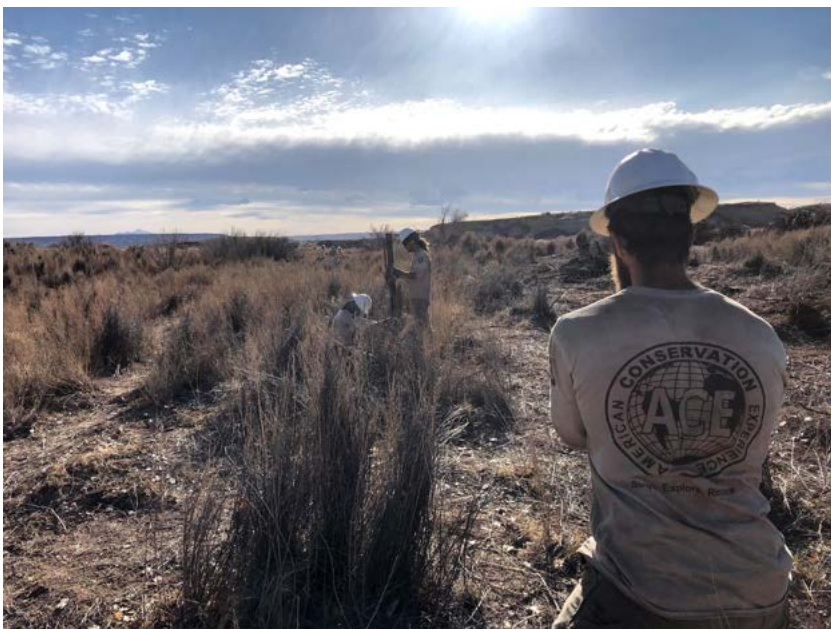
(Left) Corps members line out and set t-posts that will help support the wire. The process here is referred to as "Shooting the Line." One person stands at the brace and directs those working with them where to place the post .
